UNIVERSITY OF WISCONSIN - MADISON
CHEMISTRY INSTRUCTIONAL ADDITION AND RENOVATION

APPENDICES TO THE EXECUTIVE REPORT
VOLUME 2 OF 2

APPENDIX A

FACILITY ASSESSMENT

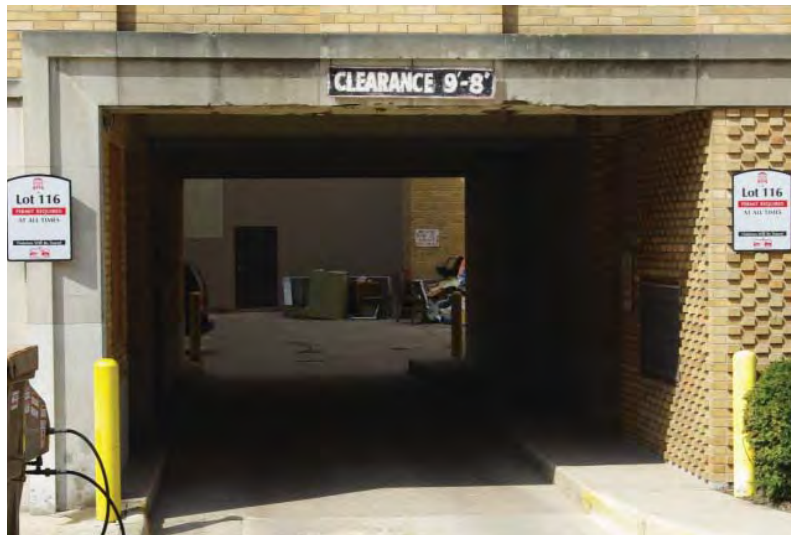
ACCESS TO COURTYARD AND TANK STORAGE AREA

From a site analysis point of view, the MSC was limited by a number of factors. Currently, the issues that effect the day to day operations of the MSC complex aren't necessarily crippling. We knew however, that what we were proposing to do would bring an additional burden onto the various infrastructure in place serving the buildings.

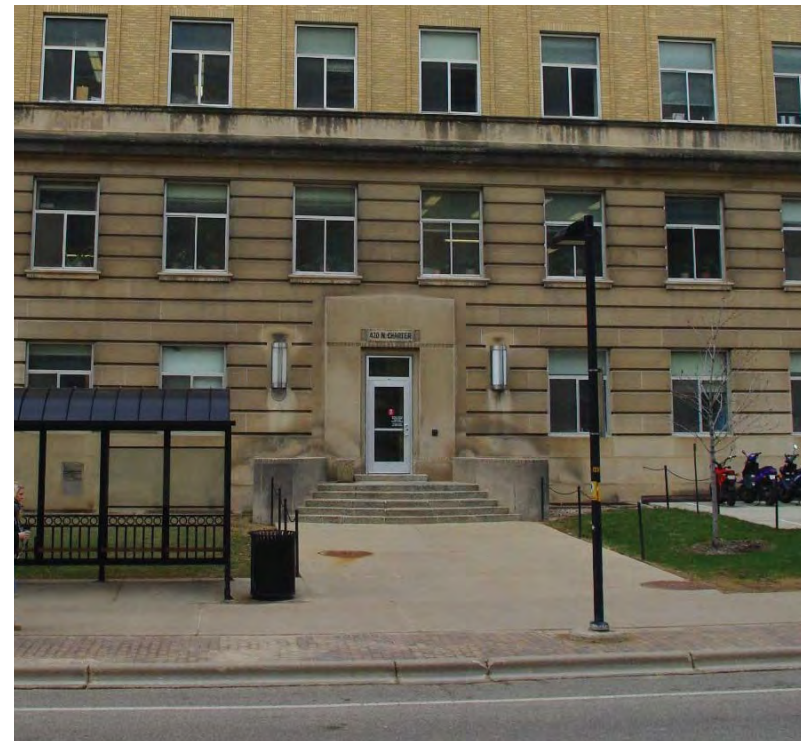
EAST BUILDING ENTRANCE

The space we wished to utilize was on the East side of the facility. The entry at this side of the building is a single door that is not wheelchair accessible. Our best hope for bringing the 5,000 or so students through per semester would have been to add an addition to the building with new stairs and elevators more or less dedicated to the chemistry Department.

Some of the current elevators were in need of modernization with one currently out of service.
