UNIVERSITY OF WISCONSIN - MADISON
CHEMISTRY INSTRUCTIONAL ADDITION AND RENOVATION

APPENDICES TO THE EXECUTIVE REPORT
VOLUME 2 OF 2

APPENDIX A

FACILITY ASSESSMENT

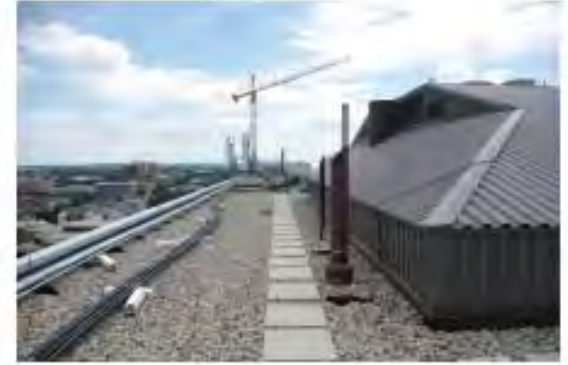
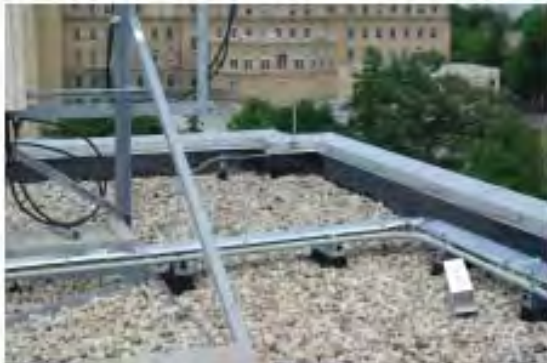
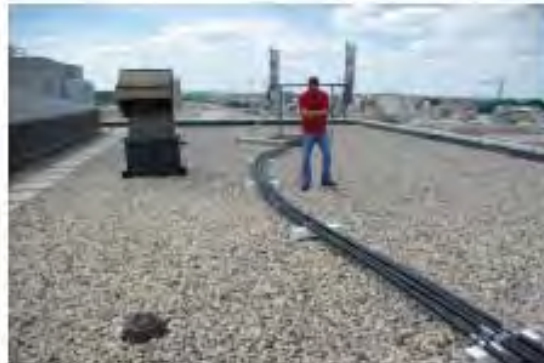
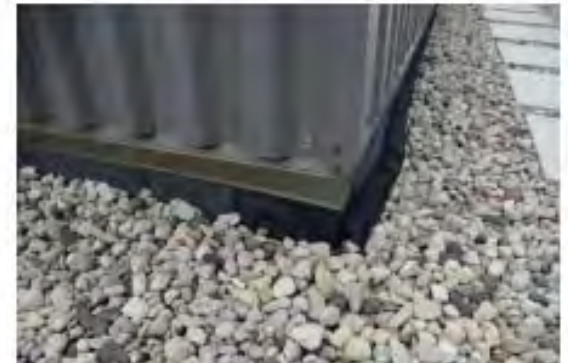
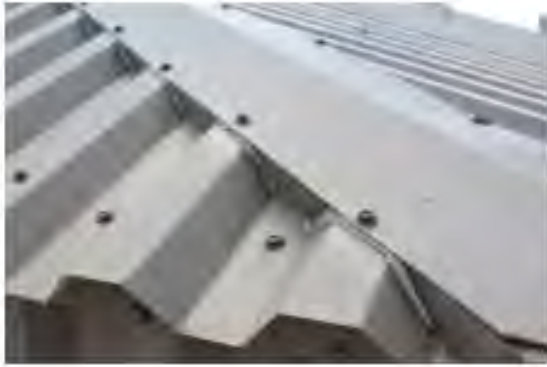
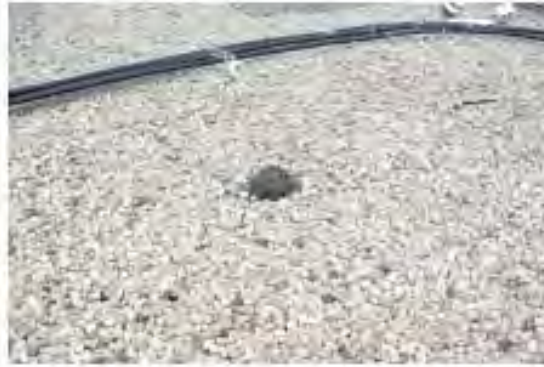
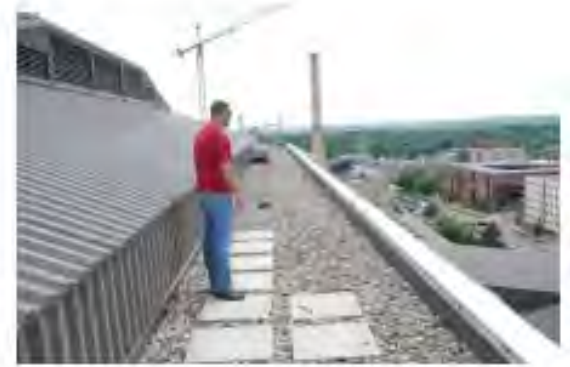
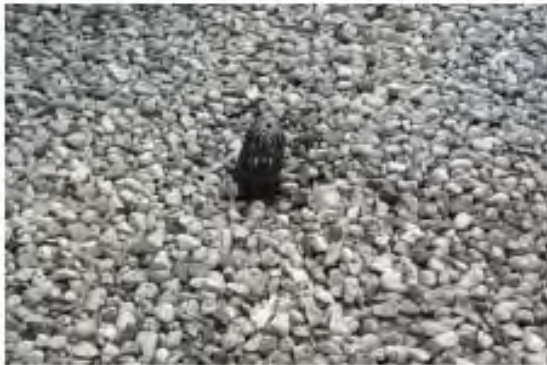
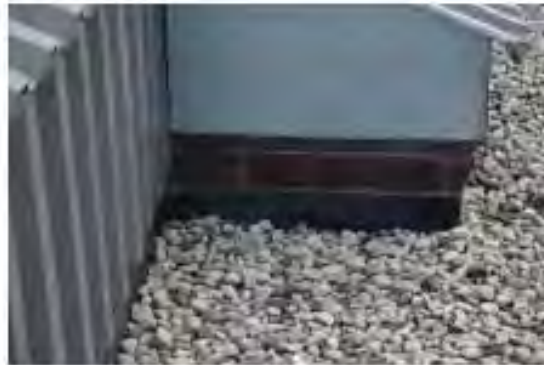
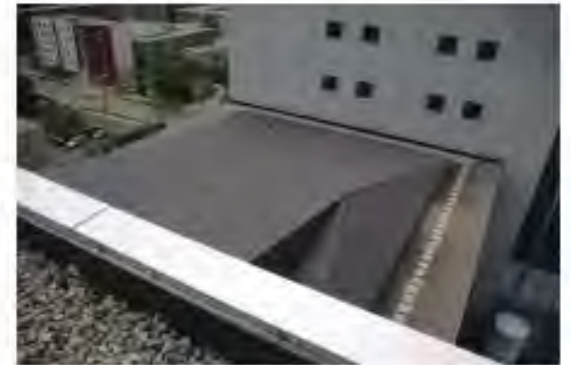
Roof D4 - doghouse	Corrugated Metal			2000 SF	7139-7146	3
		Roof D5	EPDM Rubber with 2" Rock Ballast -	Original to Building - Prevalent moss and deterioration to felt beneath ballast		13253 SF	7104-7113	4
		Roof D6	Corrugated Metal Penthouse roof			6000 SF	7104-7111	3
B3020	Roof Appurtenances							
		Railing	No railing Present on any of the roofs					
B3040	Traffinc Bearing Horizontal Enclosures							
B3060	Horizontal Openings							
B3080	Overhead exterior Enclosures

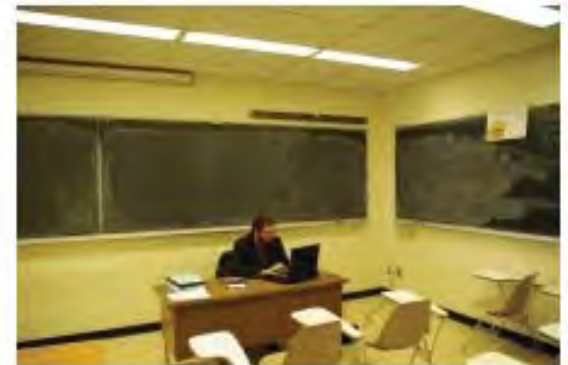
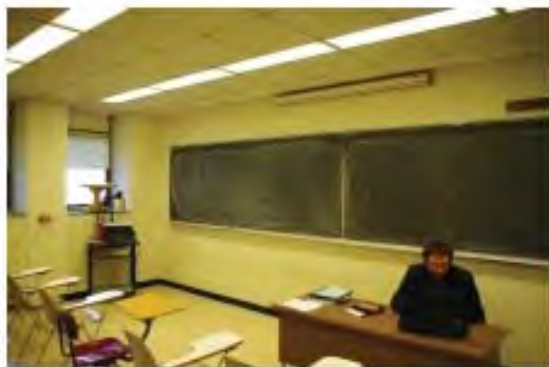
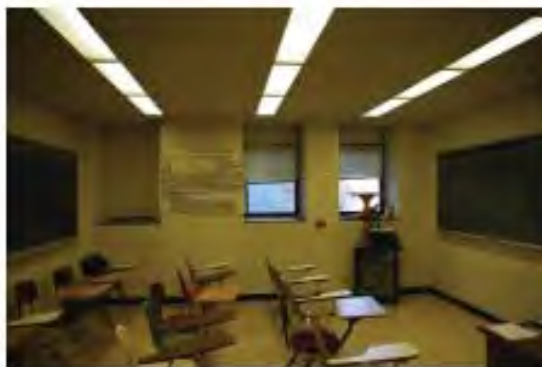
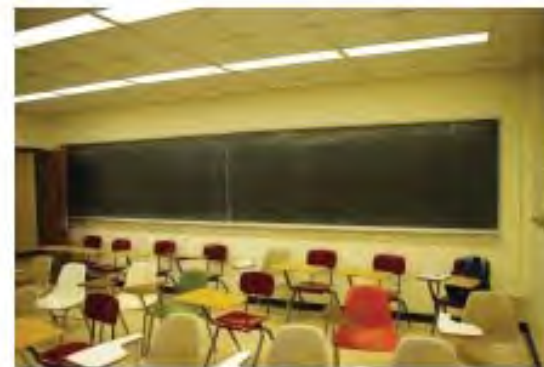
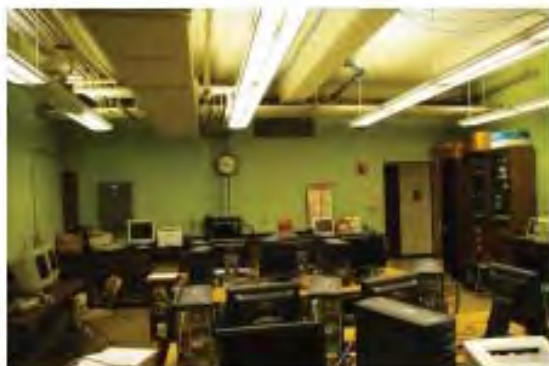
INTERIOR					
ROOM #	ROOM TYPE	ROOM DESCRIPTION	CONDITION COMMENTS	PHOTOS	OVERALL RATING
2377	2377	Classroom		6372-6376	3
2377	CODE	ITEM	DESCRIPTION	CONDITION	PHOTOS
2377	C	INTERIORS			
2377	C10	Interior Construction			
2377	C1010.10	Interior Fixed Partitions	CMU		2
2377					
2377	C1010.40	Interior Demountable Partitions			
2377	C1010.50	Interior Operable Partitions			
2377	C1020	Interior Windows			
2377	C1030	Interior Doors	1 Wood Door - Type C - Grill needs replacement, Frame needs paint, Obsolete hardware		4
2377					
2377					
2377	C1040	Interior Grilles & Gates			
2377	C1060	Raised Floor Construction			
2377	C1070	Suspended Ceiling Construction	ACT		4
2377	C1090	Interior Specialities -			
2377	C20	Finishes			
2377	C2010	Wall Finishes	Paint on CMU		3
2377			VWB		3
2377	C2030	Flooring	12" VCT		2
2377					
2377	C2040	Stair Finishes			
2377	C2050	Ceiling Finishes			
2377					
2377	E20	Furnishings			
2377	E2010	Fixed Furnishings	Chalkboards	(5) - chalkboards are bulging out	5

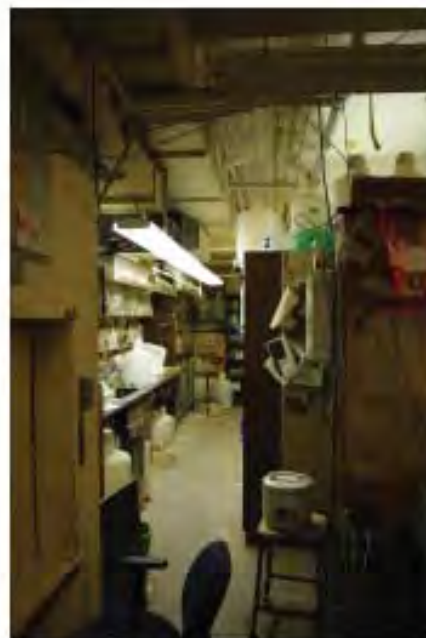
IMGP6398.JPG

2370			Vented Cabinet	SW corner - Racking, doors don't completely close - broken glass sliding panels (20%) broken	6398	6
2370			Shelves	Wood shelf with metal brackets - Delaminating, shelves are deteriorated from chemicals, random nails used to hang items		6
2370						
2370						
2370	E2050	Movable Equipment				
2370

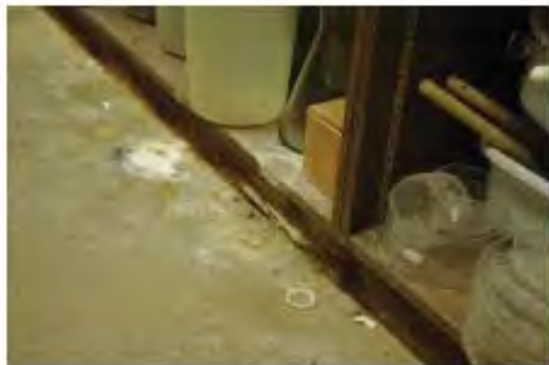
IMGP6409.JPG

2370	C2030	Flooring	Terrazzo	Floor is partially terrazzo	5	
2370			Sealed Concrete	Heavy chemical staining	5	
2370	C2040	Stair Finishes				
2370	C2050	Ceiling Finishes	ACT	Mismatched Tiles	4	
2370						
2370	E20	Furnishings				
2370	E2010	Fixed Furnishings	Vented Cabinet	NW Corner - Horiz. Glass sliding doors, top vented, panels are seperating	6408	6
2370			Prep Sink	West Wall - Delaminating wood veneer, asbestos top, heavily corroded fixtures, shlef brackets above highly corroded and holding heavy liquids	6406, 6407	6
2370			Storage Shelving	Center of Room - Wood with metal brackets - heavily corroded brackets, toe kicks completely disintegrated	6410, 6411	6
2370			Coat Closet	East Wall - Not suitable, can't close door		6
2370			Service Counter	East Wall - Plam top is cracked, delaminating - counter is heavily worn	6409	6
2370			Counter Doors	Hollow Core Wood - counterweighted, chipped and abraised, Not all locking mechanisms work	6409	6

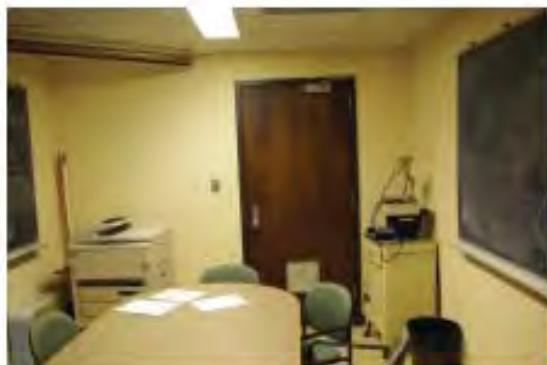
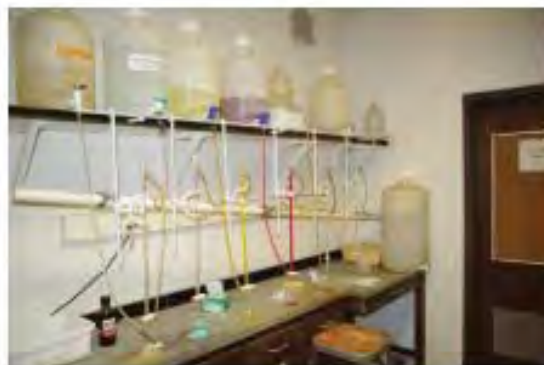
IMGP6454.JPG

INTERIOR						
ROOM #	ROOM TYPE	ROOM DESCRIPTION	CONDITION COMMENTS	PHOTOS	OVERALL RATING	
2372	2372	Miscellaneous	Conference Room	6454-6455	3	
2372	CODE	ITEM	DESCRIPTION	CONDITION	PHOTOS	RATING
2372	C	INTERIORS				
2372	C10	Interior Construction				
2372	C1010.10	Interior Fixed Partitions	CMU		2	
2372						
2372	C1010.40	Interior Demountable Partitions				
2372	C1010.50	Interior Operable Partitions				
2372	C1020	Interior Windows				
2372	C1030	Interior Doors	1 Wood Door - Type A - Broken Closer		3	
2372						
2372						
2372	C1040	Interior Grilles & Gates				
2372	C1060	Raised Floor Construction				
2372	C1070	Suspended Ceiling Construction	ACT		4	
2372	C1090	Interior Specialities -				
2372	C20	Finishes				
2372	C2010	Wall Finishes	Paint on CMU		3	
2372						
2372	C2030	Flooring	12" VCT		3	
2372						
2372	C2040	Stair Finishes				
2372	C2050	Ceiling Finishes	ACT	Dirty, Stained	4	
2372						
2372	E20	Furnishings

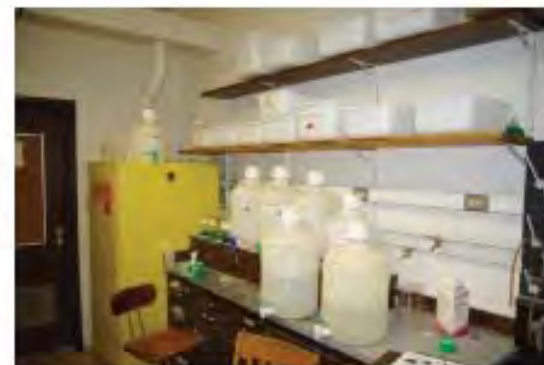
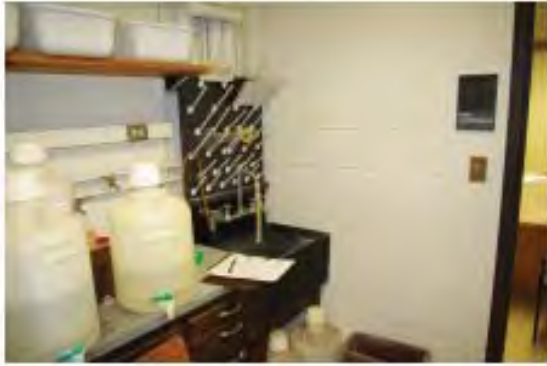
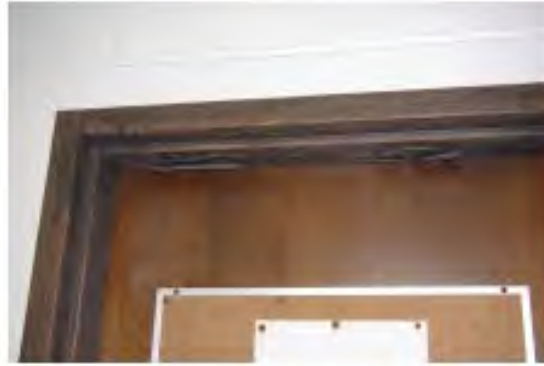
IMGP6456.JPG

INTERIOR					
ROOM #	ROOM TYPE	ROOM DESCRIPTION	CONDITION COMMENTS	PHOTOS	OVERALL RATING
2372A					
2372A	2372A	Stock Room	Unmanned Stock room	6456-6458	5
2372A	CODE	ITEM	DESCRIPTION	CONDITION	PHOTOS
2372A	C	INTERIORS			
2372A	C10	Interior Construction			
2372A	C1010.10	Interior Fixed Partitions	CMU		2
2372A					
2372A	C1010.40	Interior Demountable Partitions			
2372A	C1010.50	Interior Operable Partitions			
2372A	C1020	Interior Windows			
2372A	C1030	Interior Doors	1 Wood Door - Type A - heavily corroded frame due to acid in the air	6459	5
2372A			2		5
2372A					
2372A	C1040	Interior Grilles & Gates			
2372A	C1060	Raised Floor Construction			
2372A	C1070	Suspended Ceiling Construction			
2372A	C1090	Interior Specialities -			
2372A	C20	Finishes			
2372A	C2010	Wall Finishes	Paint on CMU		3
2372A					
2372A	C2030	Flooring	Sealed Concrete		
2372A					
2372A	C2040	Stair Finishes			
2372A	C2050	Ceiling Finishes	Paint on Structure		4

2372A					
2372A	E20	Furnishings			
2372A	E2010	Fixed Furnishings	Benches	Qty (2) - Granite top, wood base - heavy damage and staining, pitting on hardware	6
2372A			Shelves	Qty (3) - Corroded brackets	4
2372A			Lab Sink		5
2372A					
2372A	E2050	Movable Equipment	Cabinet	Flammable liquid cabinet	4
2372A

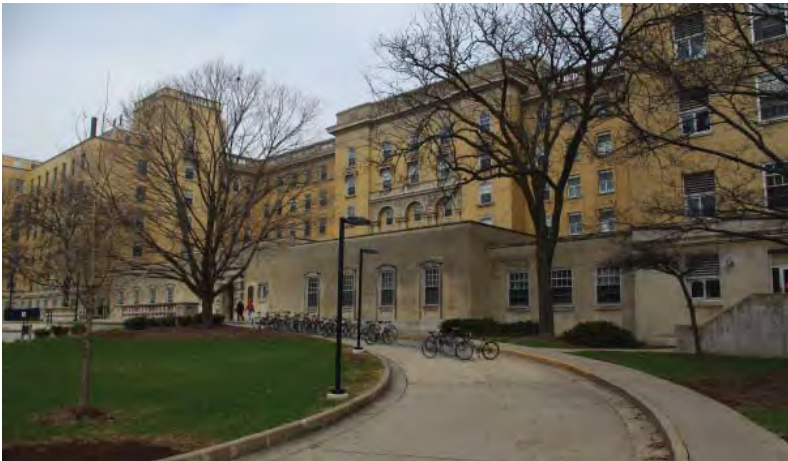
MSC COMPLEX

The MSC was found to be unsuitable for use as undergraduate Chemistry teaching labs. The structure was designed to meet standards of the time, and existing drawings indicate the floor live loading was designed at 60lbs/sf for patient room areas. Current criteria for laboratory spaces are a minimum 100lbs/sf. Reinforcing would be required to accommodate corridor placement as well as a new rooftop penthouse. The floors would require nearly a complete gut and remodel, with the corridor shifting outboard to form a single loaded plan with long, rectangular labs on one side that are bisected by a dense row of columns. The orientation of the labs as well as existing column locations would create

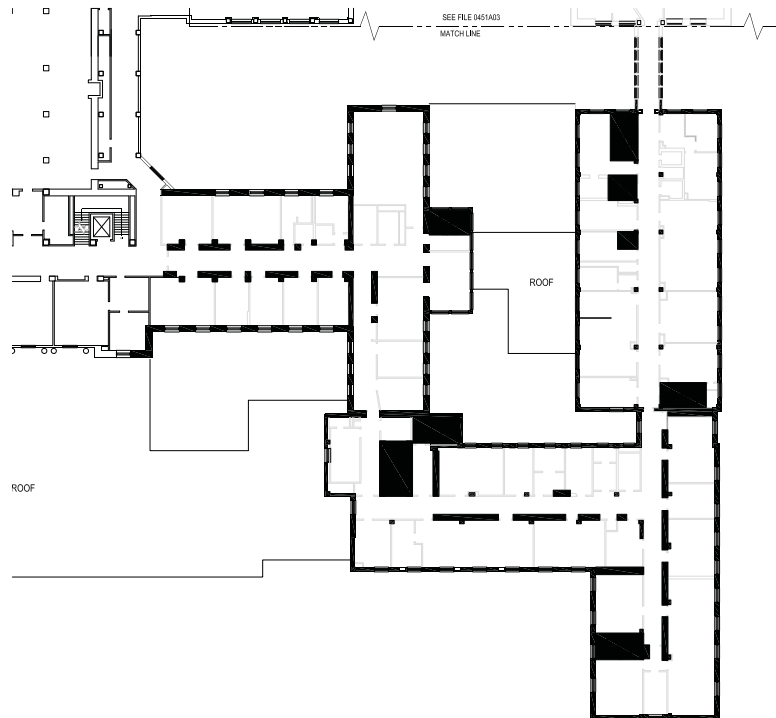
POCHE DIAGRAM

that the structure and ventilation shafts imposed on the plans. We were immediately concerned with the safety issues that a lab filled with thick columns presents. In the sample programming diagram above, we were able to prove that the spaces could be accommodated, but when the furniture and equipment was laid out, the functionality issues become obvious.

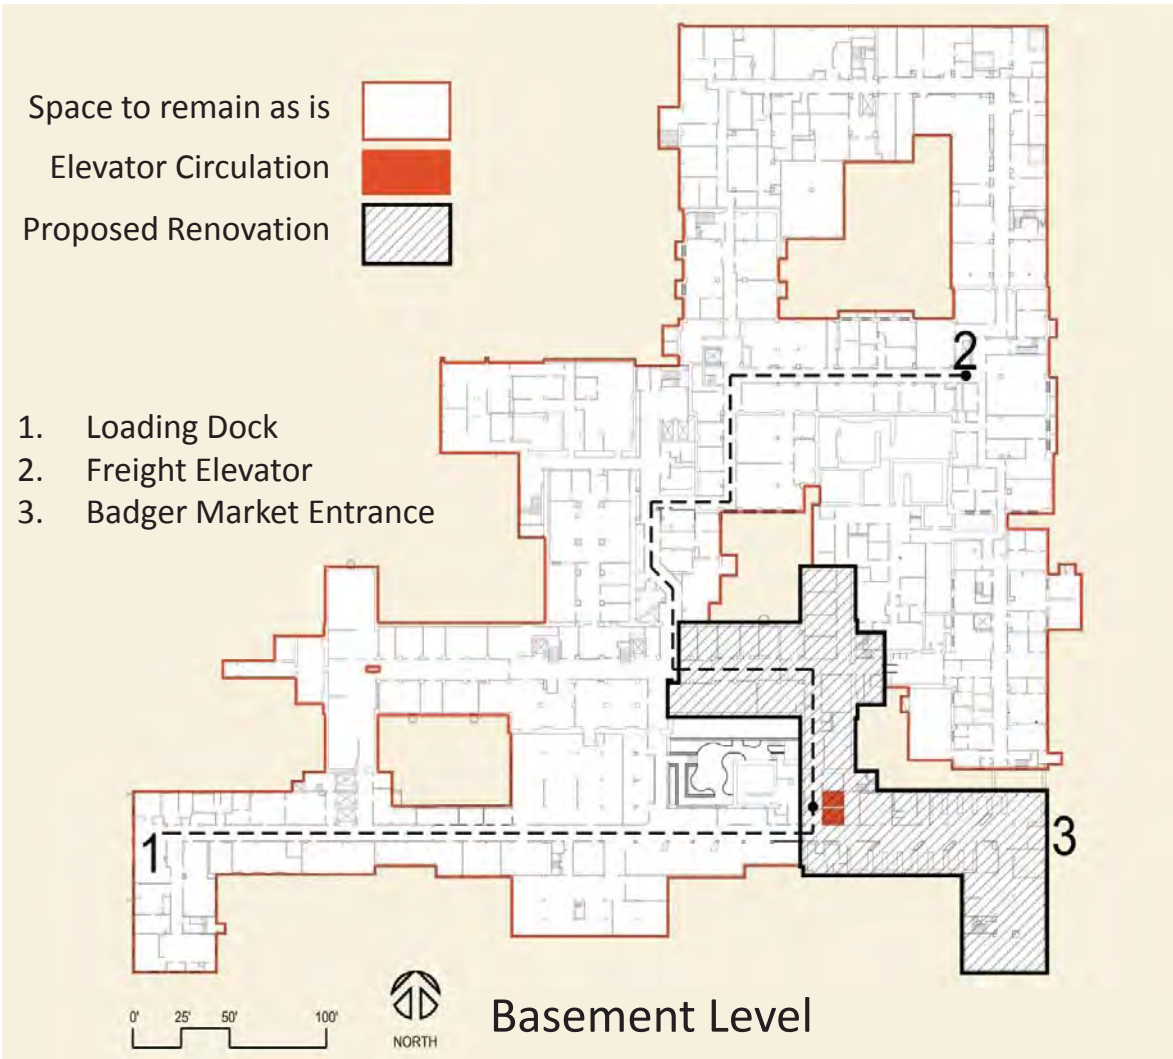
This diagram shows the Basement level and the various connections that one would likely make. Access from the loading dock to the freight elevator is challenged by a long and circuitous route through corridors of various sizes with lots of intervening doors and tight turns.

The lower level entrance through the Badger Market is close to the core elevators that the chemistry program would most likely utilize, but it is not an accessible entry as it is below grade.

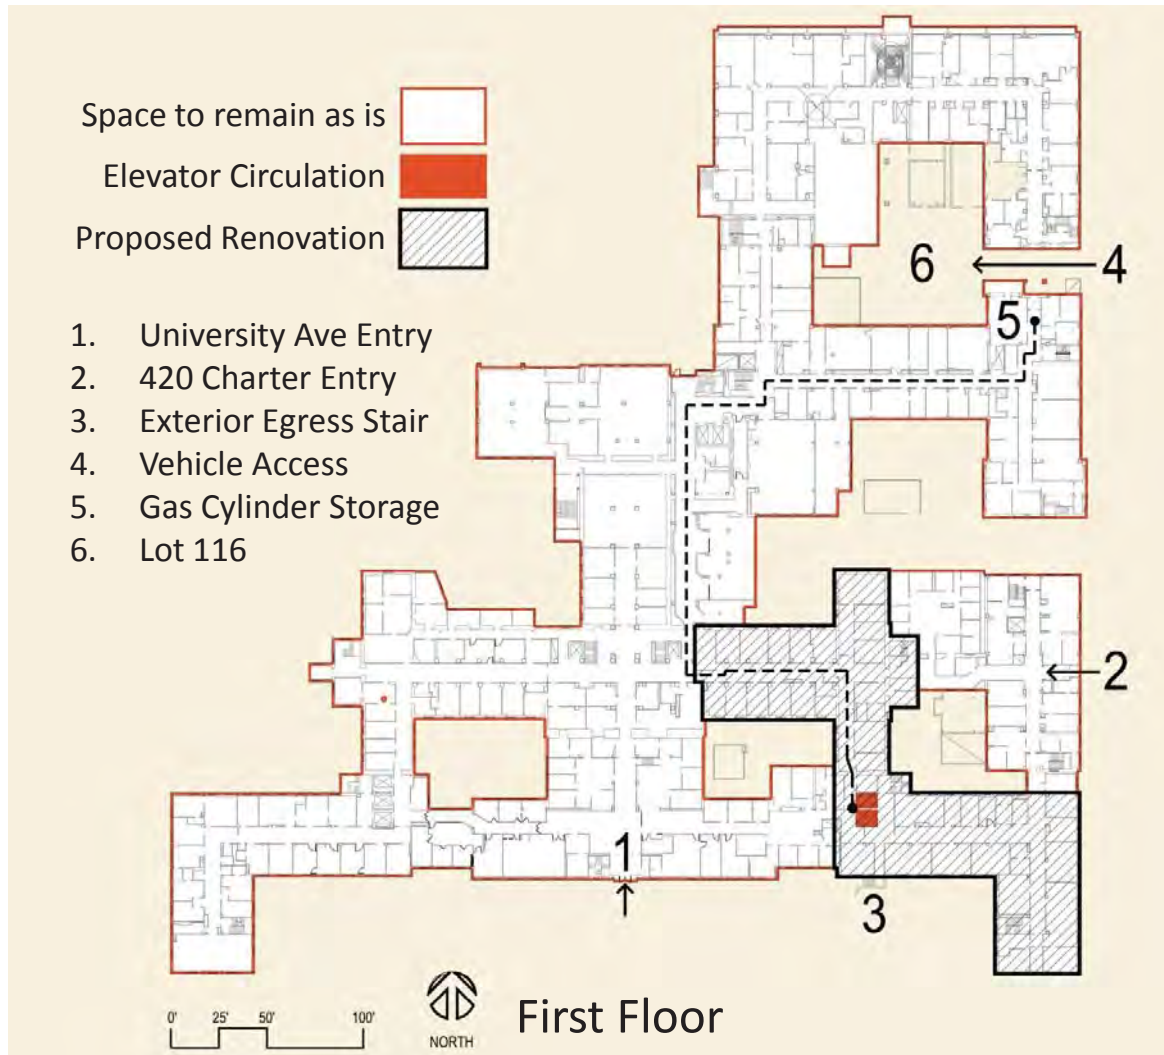
ADJACENCY DIAGRAM

The first floor diagram shows various connections and access points crucial to the chemistry program. Gas cylinder storage is an important consideration for the instructional laboratory space. This diagram indicates that the route from that space to the department is long and circuitous.
